Safety Matters

Isle of Man Aircraft Registry

Issue No: 01/17

Safety Matters...

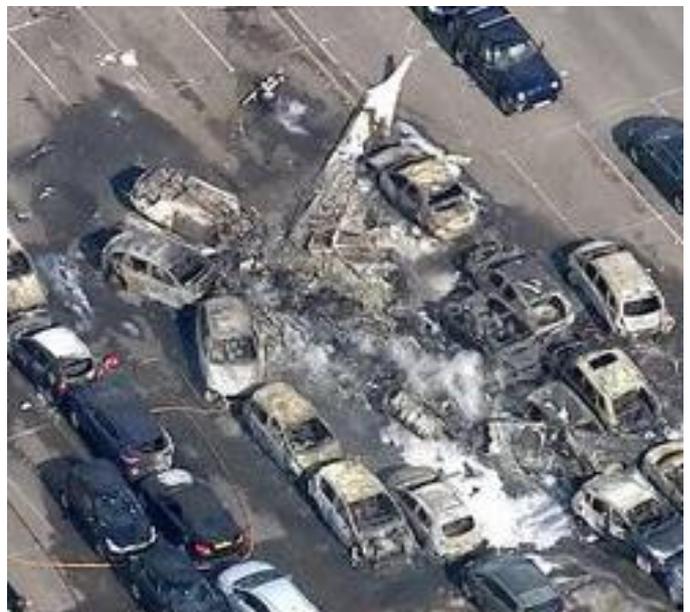
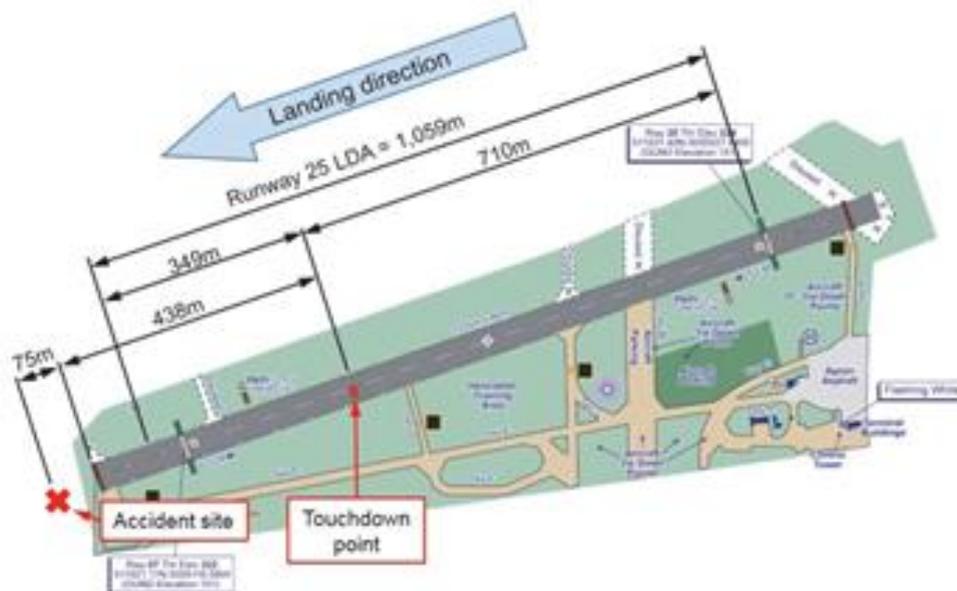
The aircraft entered the visual circuit to land on Runway 25 at Blackbushe. A number of TCAS alerts occurred while flying in the circuit, and the pilot manoeuvred the aircraft until it was significantly higher and faster than normal for a visual approach. Following several TAWS alerts, the aircraft crossed the runway threshold 43 kt above the target threshold speed. The AAIB's report into the accident concluded that despite the pilots attempt to deploy the jet's speed brakes, they remained retracted as the flaps on the wing were deployed. The aircraft floated before touching down 710m beyond the threshold, with only 438m of paved surfaced remaining and overran the runway end. It collided with an earth bank, and then cars in a car park, causing the wing to separate and a fire to start. The four occupants were fatally injured.

Several factors combined to create a very high workload for the pilot. This included the pilot being exposed to 66 audio warnings, instructions and messages during the three minutes and 32 seconds before reaching the start of the runway. The report stated: "It is possible that in these circumstances the pilot ... fixated on his initial strategy - landing - and lacked the mental capacity to recognise that the approach had become unstable and should be discontinued." The AAIB also ruled out bad weather or any technical defects with the aircraft and also confirmed that the pilot was free of any substances that may have reduced his performance.

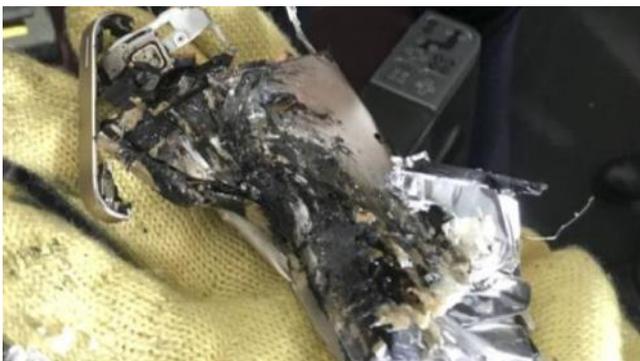
The crushed mobile phone below was found between two seats on a Qantas A380 flying Sydney to Dallas-Fort Worth after smoke was detected in the upper deck.

“Recently there have been a small number of incidents of phones and tablets catching fire on board aircraft worldwide. Causes included crushing in the aircraft seat mechanism. Operators of aircraft with seats featuring electrical or mechanical means of adjusting position should consider briefing passengers to take care of their personal electronic devices. Passengers should also be told that, if this happens, they should not move the seat and inform the cabin crew, who can assist. Cabin crew procedures should be amended accordingly, including an explanation that assistance from engineering may be needed on the ground”.
