Safety **Matters**

Issue No: 01/18

THE IMPORTANCE OF PRE-FLIGHT CHECKS

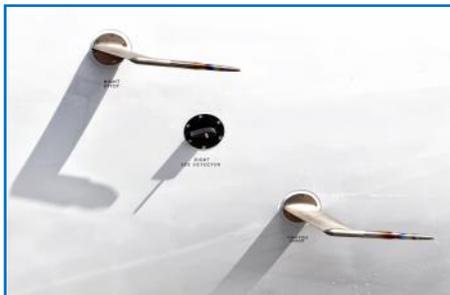
Investigators believe the crew of a crashed Antonov An-148 did not carry out a crucial checklist which should have included a deferred confirmation that the pitot-static heating system was active.

Analysis of the FDR shows that, before take-off, the aircraft's integrated information system indicated "no heating" on any of the three pitot-static sensors. "Almost immediately after taxiing the aircraft to the runway, the crew received take-off clearance," says Rosaviatsia.

The report states that the "before take-off" checklist was "not performed", suggesting that the pilots did not confirm whether the pitot-heating was active. The crew instead commenced the take-off roll. Some 2min 30s into the flight the aircraft began to display unreliable airspeed indications, and the crew lost control of the jet. The Saratov Airlines twinjet came down a few minutes after departure from Moscow Domodedovo on 11 February 2018.

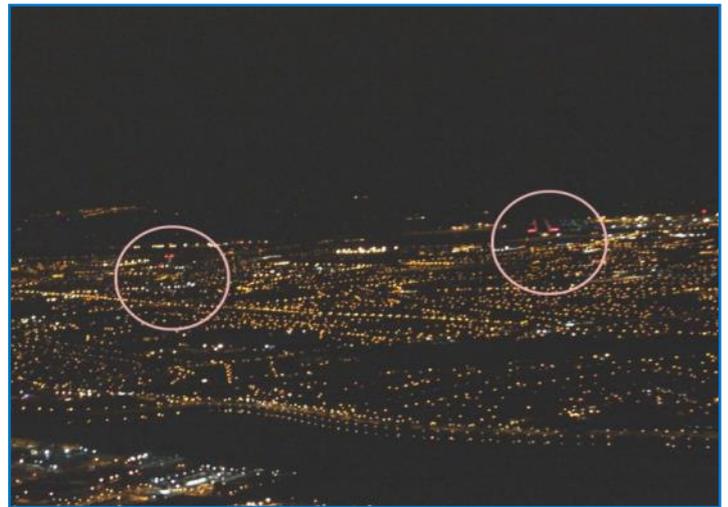
[At Dublin in 2007](#) a MD83 aircraft at night came within 1700 feet laterally and 200 feet vertically of a hotel whose lights they had mistaken for the runway while completing a VOR-DME approach. The hotel lights are circled on the left in the picture above with the runway threshold circled to the right.

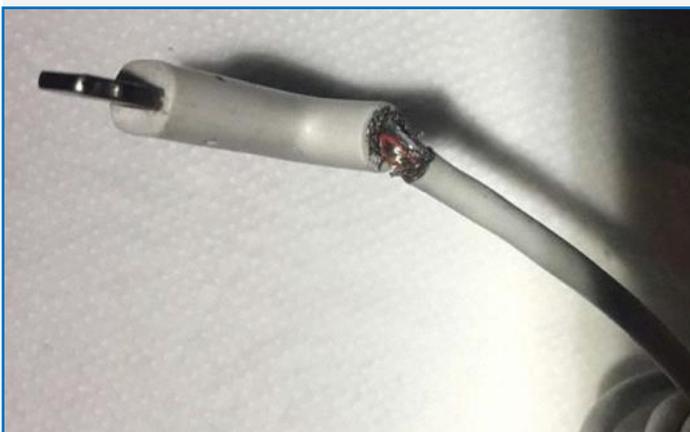
A Smartwings Boeing 737-800, performing a flight from Ras al Khaimah (United Arab Emirates) to Warsaw (Poland), was enroute at FL360 near Tabriz (Iran) about 2.5 hours into the flight when the crew observed smoke and strong odour from the right hand side of the cockpit.

The USB power cable had created an electrical short circuit due to wear of the cable. The parts were replaced and a fleet wide inspection of all power cables was conducted. The operational documentation was changed as well on the base of this defect.

In response the first officer disconnected his iPad from the USB charger, the crew also pulled the related fuses to stop any further combustion. After ensuring that the smoke and odour had stopped, the crew continued the flight to Warsaw continuously monitoring the situation for a safe landing.

The chance of such occurrences can be reduced by pre-flight checks, correct cable routing and the use of certified accessories and equipment to ensure safe operation.
